To ensure your tap water is safe, clean and secure, Tucson Water conducts approximately 14,500 individual tests each year on the water in the main distribution system — before it reaches your home. Test results for key parameters are reported by 10 water quality zones for a water distribution system that covers some 375 square miles.

Main Water System

TEST RESULTS BY WATER QUALITY ZONE

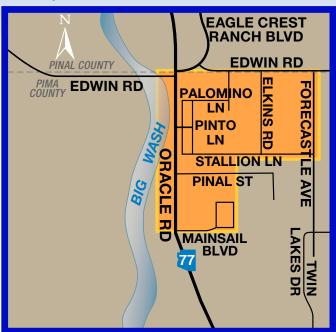
Catalina Water System

Catalina is a community partially served by Tucson Water. It has about 400 connections, supplying water to about 1,000 persons with water from two wells.

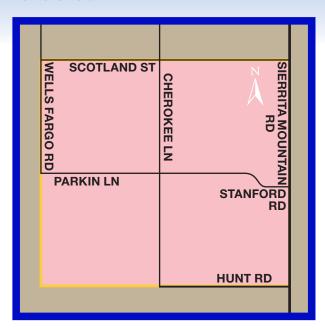
Sierrita Foothills Water System

This is a small community by the Three Points area, with 30 connections supplying approximately 75 people from one well.

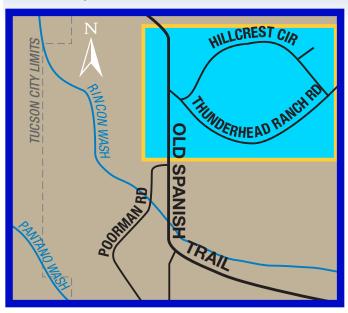
Thunderhead Ranch Water System

Thunderhead Ranch is a small subdivision west of Old Spanish Trail and about one and a half miles south of Irvington Road. It has about 57 connections supplying about 160 persons with water from two wells.

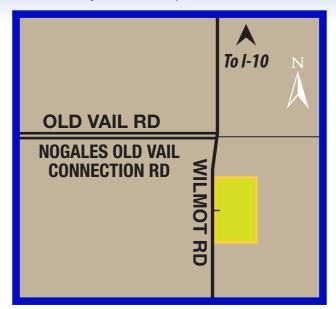
Tucson Police-Fire Academy Water System

The Police-Fire Academy, located south of Interstate 10 and east of Wilmot Road, was built in the late 1990s. One well supplies about 25 persons regularly, plus class members taught at this facility.

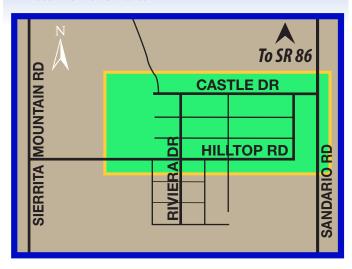
Valley View Acres Water System

Valley View Acres is a small community located north of Hilltop Road, just west of Sandario Road, with about 150 connections supplying about 470 people with water from two wells.
